CITY OF LONGMONT | Planning Department

September 18, 2023

Commercial Conditions Survey - 704 Main Street

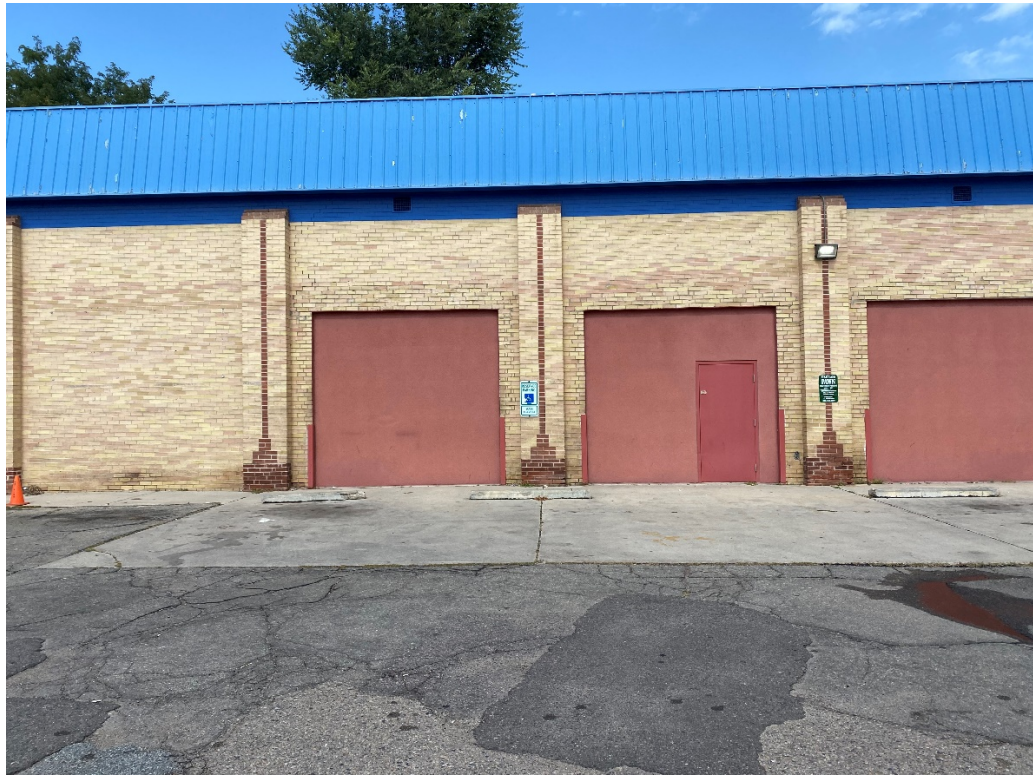
Photo 1- Facing north looking at the building façade that faces Longs Peak Avenue. Blight factors present include, deteriorated façade, roof and loading areas, deterioration of parking surface, inadequate parking striping.

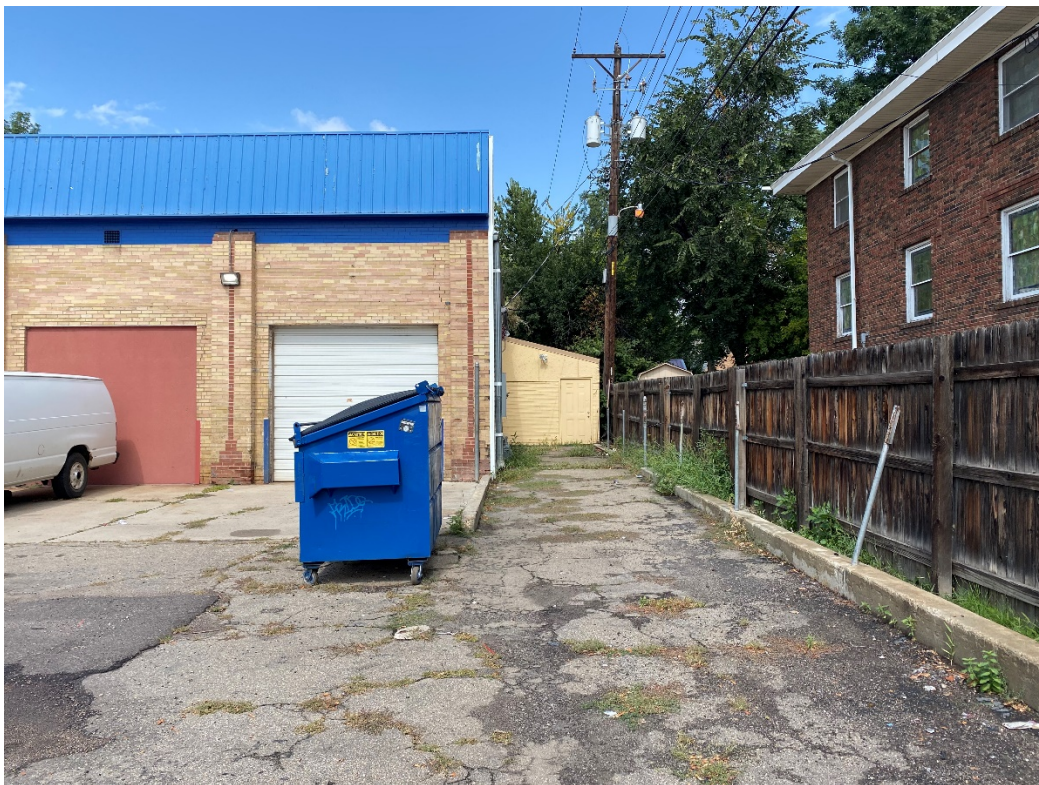
Photo 2- Looking north at the building with unscreened trash visible. Poor drainage on the site, rainfall was recorded the day prior and standing water was still present on the site. Overhead utilities are also present.

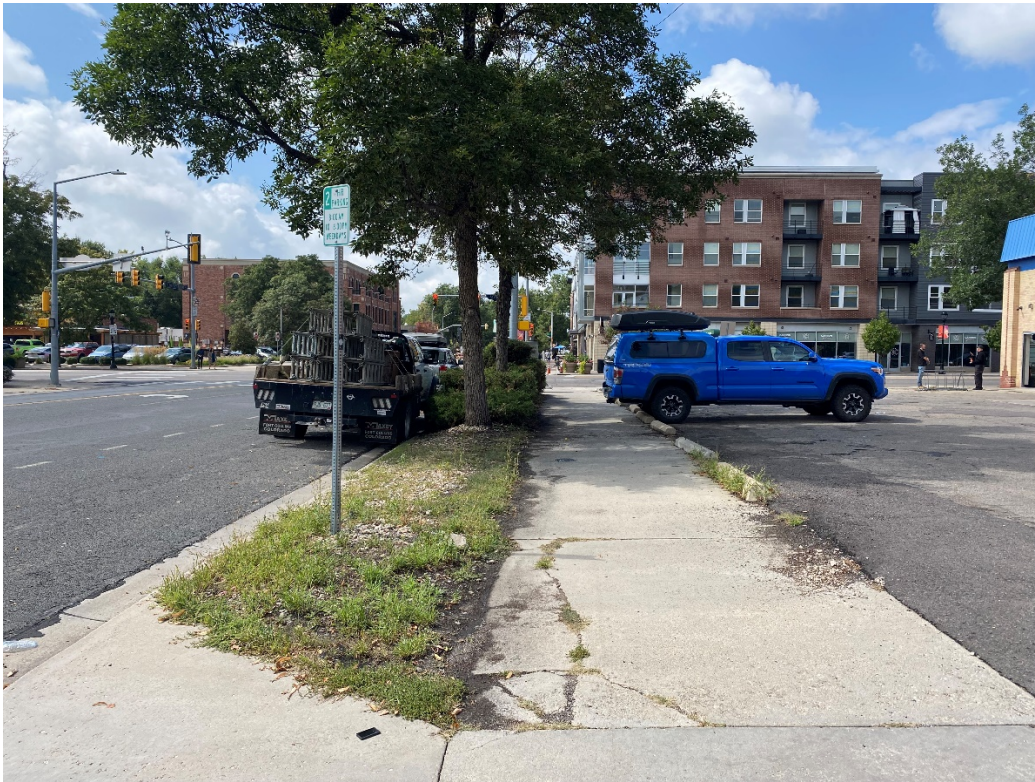
Photo 3- Looking west towards Main St. Cracked and uneven sidewalk present with insufficient street lighting.

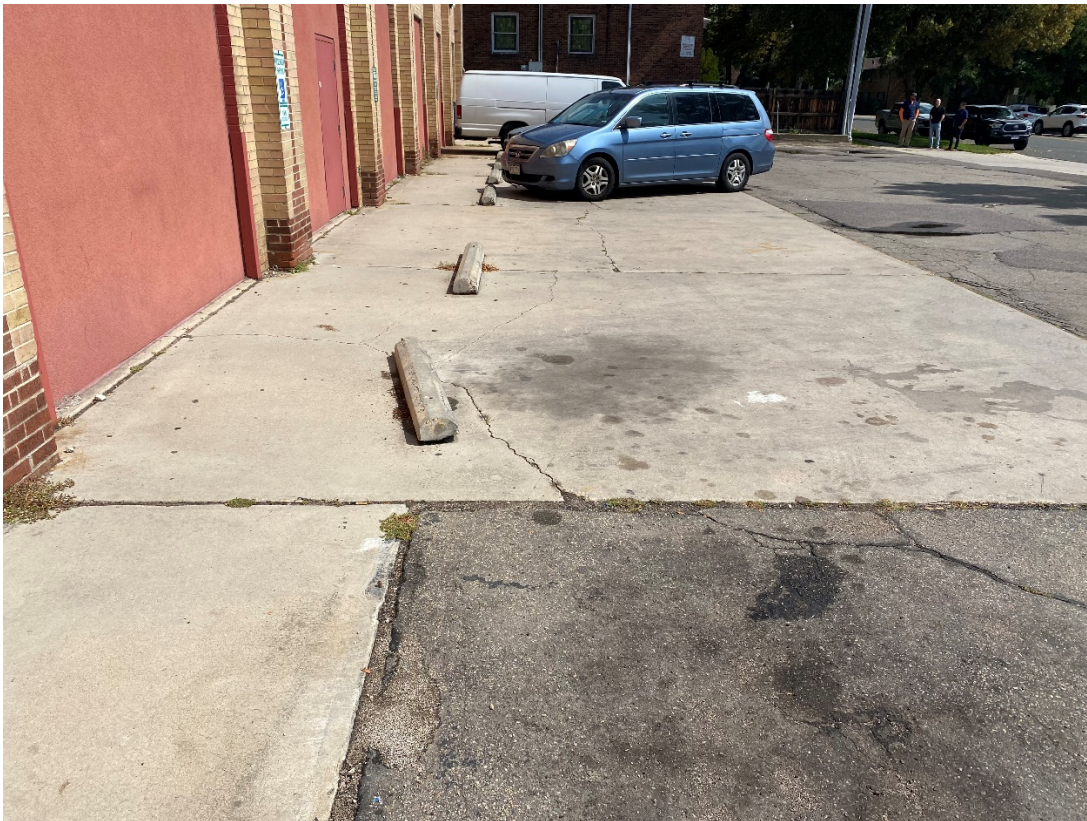
Pic 4- Looking east at the parking lot on the site. Inadequate striping, un-maintained parking surface, trash and poor drainage are all factors present at this site.

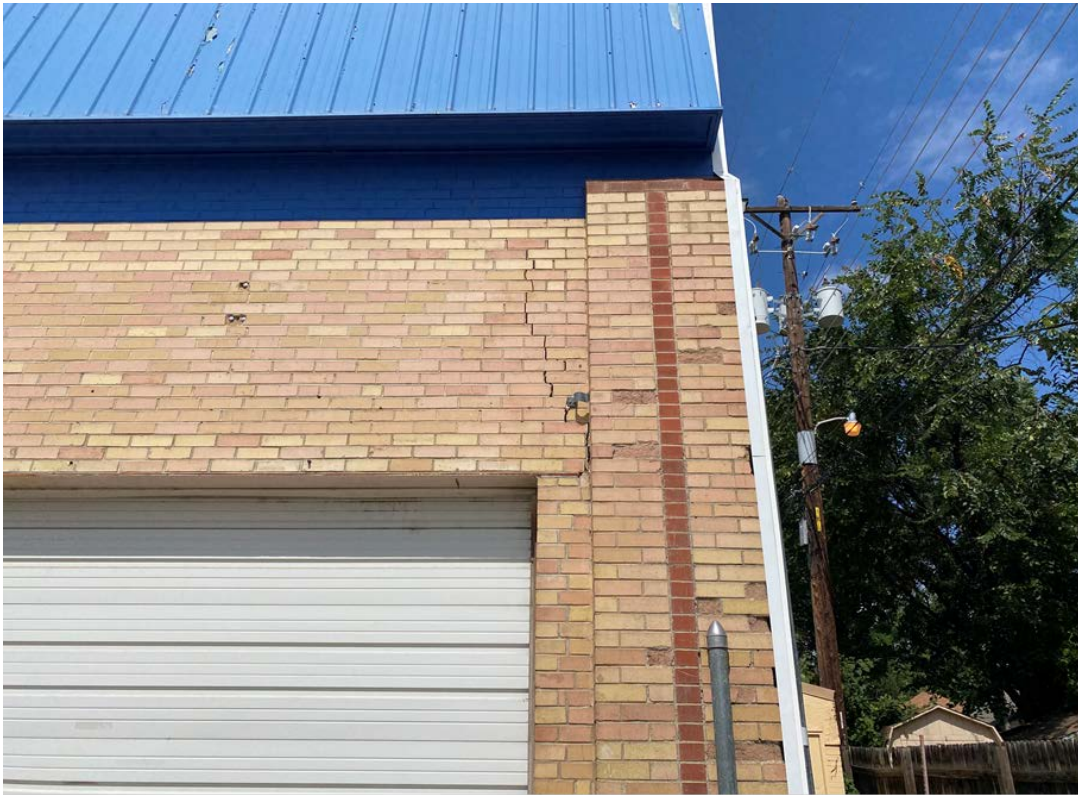
Photo 5- Close up of deteriorating building façade and roof.
