GENERAL ECOLOGICAL RESOURCES SURVEY

15.976 Acres in Section 8, Township 2 North, Range 69 West Boulder County, Colorado 80503

Western Environment and Ecology, Inc. Project Number: 745-001-02

May 18th, 2017

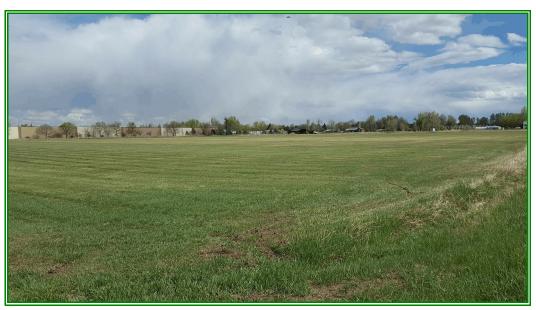
View of the property from the northwest

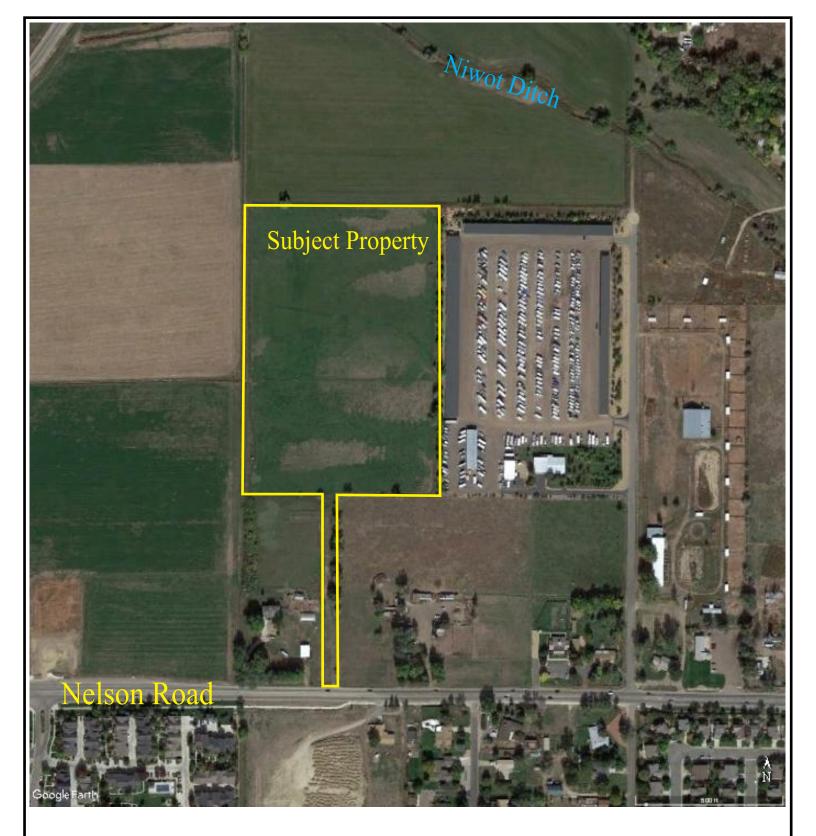
Figure 2 - Site Map 15.976 Acres within Section 8, Township 2 North, Range 69 West, Boulder County, Colorado 80503

This Phase I Environmental Site Assessment was conducted for approximately 15.976 acres within Section 8, Township 2 North, Range 69 West, Boulder County, Colorado (Figure 1). The subject property is located northwest of the intersection of Schlagel Street and Nelson Road (Figure 2). The Boulder County Assessors Office identifies no current structures on the site.

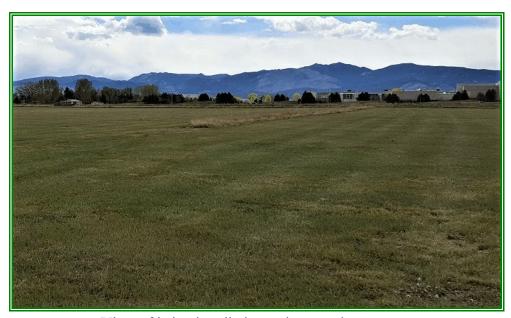
View of irrigation ditch terminus on the property

No perennial waters were observed on or directly adjacent to the project. However, an irrigation ditch system bordered the property to the north and west, and bisected the center of the site from the west to the east, terminating in the eastern portion of the property. Several head gates were observed within the ditch. Additionally, Niwot Ditch is located approximately 500 feet northeast of the property (Figure 2). Niwot Ditch does contain wetland type vegetation, including Eastern Cottonwood (*Populus deltoides*) and Nebraska Sedge (*Carex nebrascensis*). At the time of the inspection, the Niwot Ditch was dry.
