**BOULDER COUNTY
HISTORIC SITES SURVEY**

Resource Name: Carlson Farm / Wallace Property

Address: 10662 Pike Road
Longmont, CO

HISTORIC ARCHITECTURAL BUILDING STRUCTURE FORM

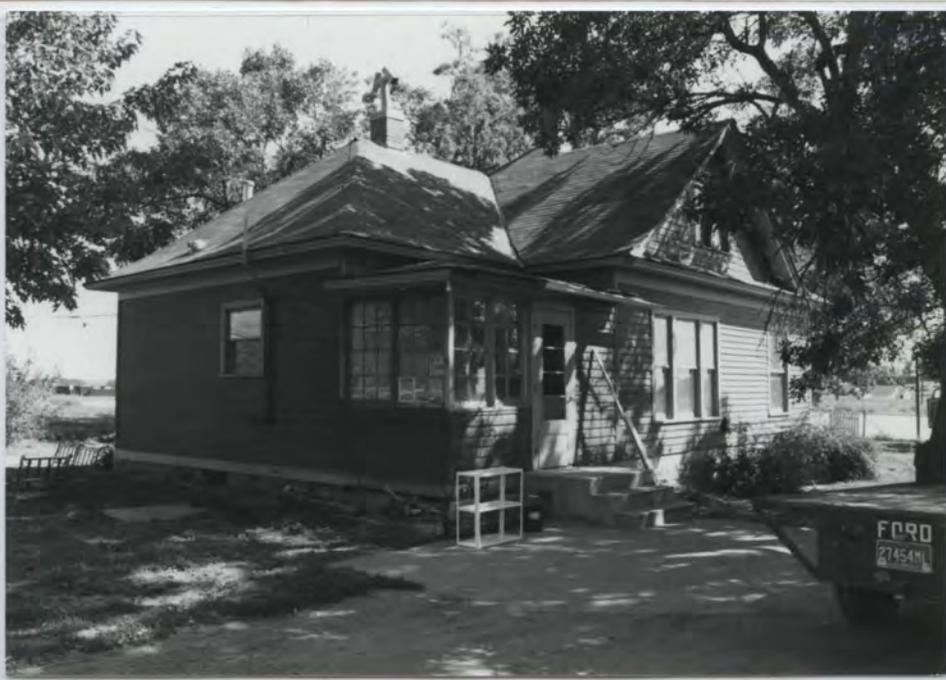
Frame 9

House

View to NE

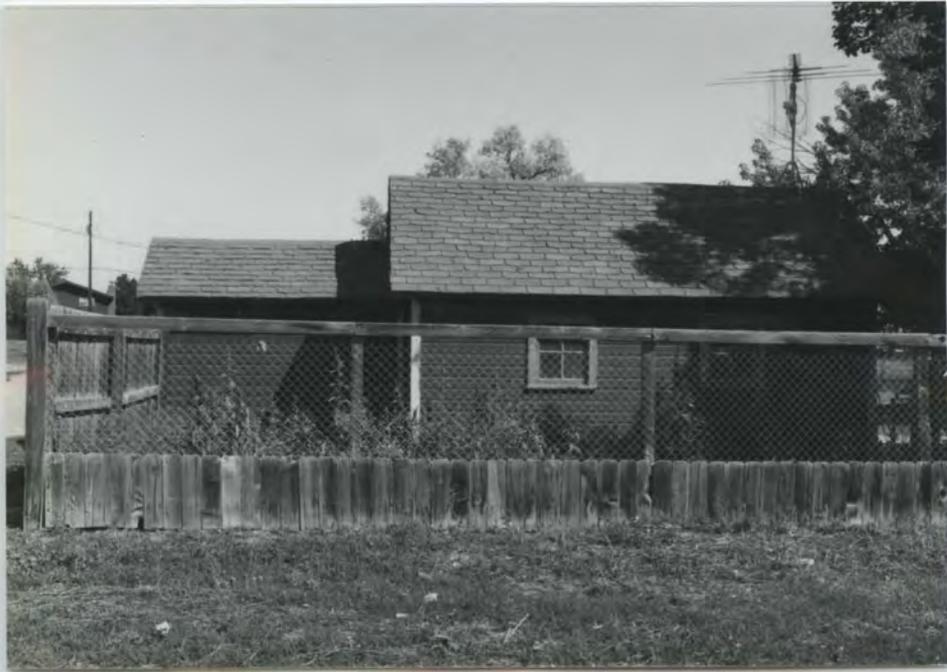
Frame 11

(site plan item B; photos: roll CM-32, frames 10-11); 10' N-S by 18' E-W, plus a 5' by 11' addition to the west elevation: this elevation does not appear on a 1949 property appraisal entry, but does appear on a 1954 appraisal entry; poured concrete foundation; painted red horizontal weatherboard siding, with painted blue 1" by 4" corner posts; moderately-pitched gable roof with brown asphalt shingles and boxed eaves; no chimney; two 4-light hopper windows, with unpainted plain wood surrounds, located on the south elevation; paired vertical wood plank doors, side-hinged with metal strap hinges, located on the east elevation; two painted blue wood-paneled doors provide access into the addition at the west end of the north elevation; building is in good condition.

Garage

View to North

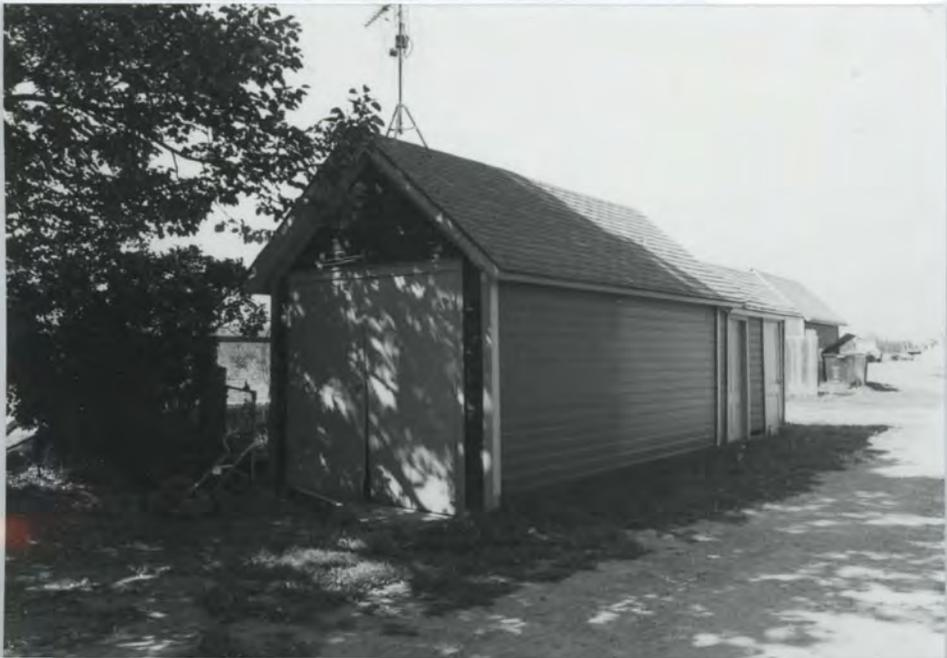
Frame 10

Garage

View to SW

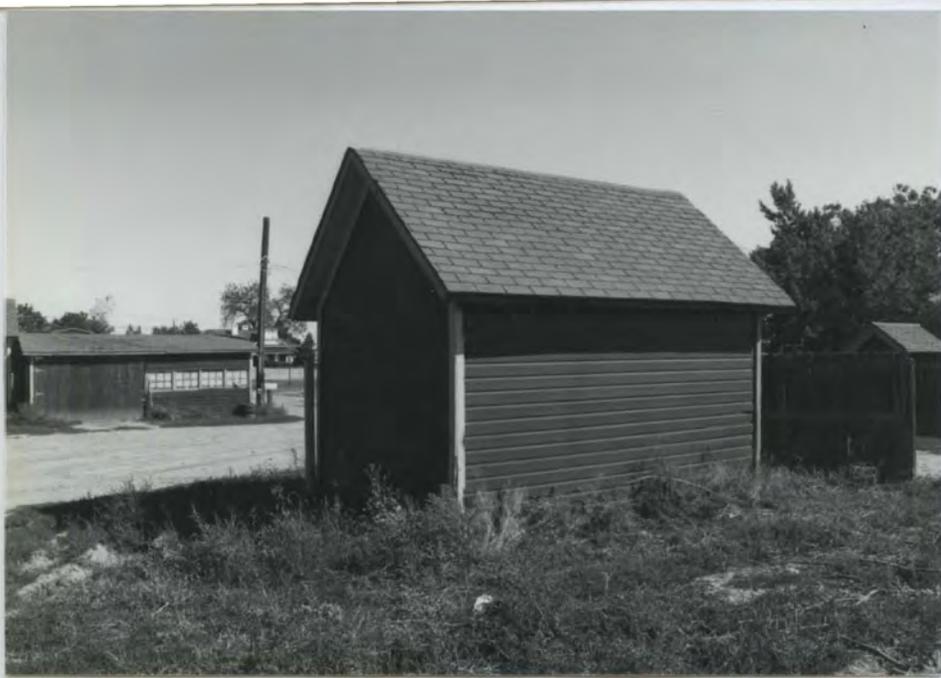
Frame 13

(site plan item C; photos: roll CM-32, frames 12-13); rectangular plan; 11" N-S by 14" E-W; no foundation visible; painted red horizontal weatherboard siding with painted blue 1" by 4" corner posts; moderately-pitched gable roof with brown wood shingles and boxed eaves; no chimney; square window opening on the north elevation has been covered with painted red horizontal weatherboard siding; openings in the upper gable ends on the east and west are also covered with horizontal weatherboard siding; painted blue vertical wood plank door, side-hinged with metal strap hinges, located on the east elevation; building is in good condition; no additions.

Shed

View to NE

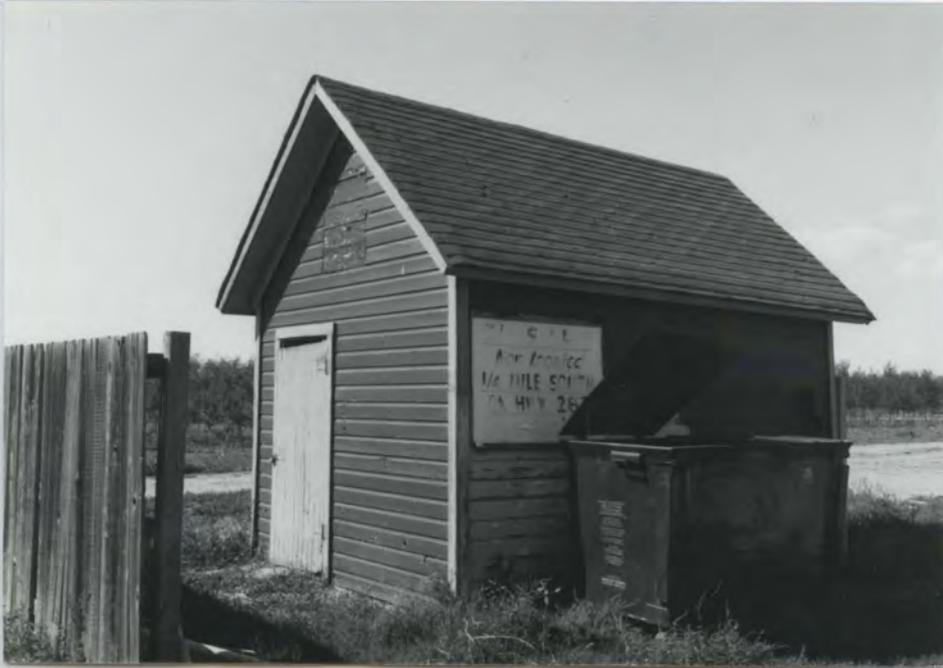
Frame 12

Shed

View to SW

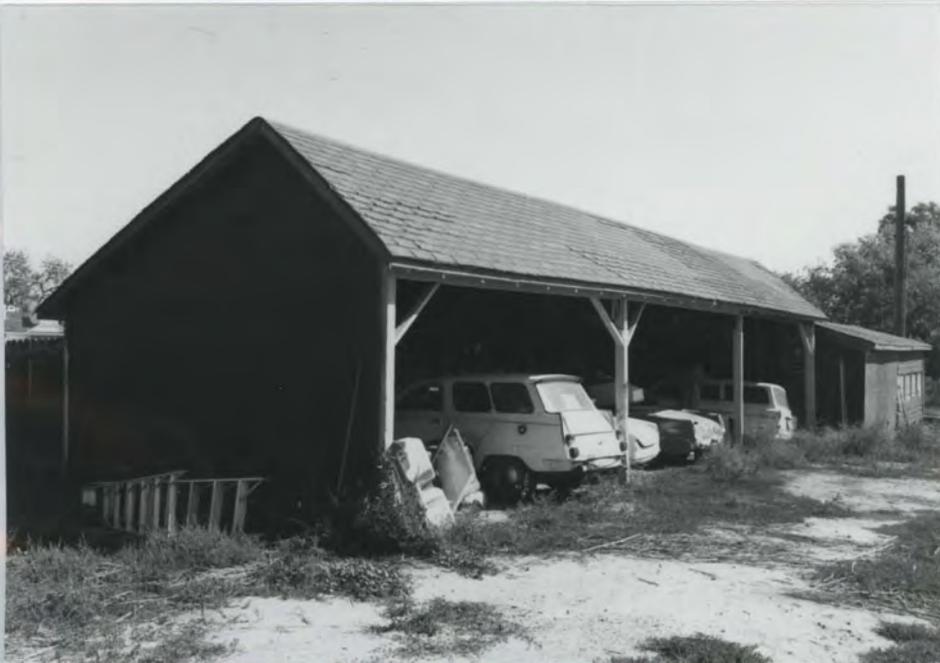
Frame 20

(site plan item F; photos: roll CM-32, frames 19-20); rectangular plan; 17' N-S by 46' E-W; hard packed earth floor; low stone perimeter walls foundation; painted red horizontal weatherboard siding nailed to 2" by 4" studs, and with painted blue 1" by 4" corner posts; moderately-pitched saltbox roof with brown asphalt shingles and exposed 2" by 4" rafter ends with fascia board; no chimney; no windows; three open bays on the south elevation, separated by 6" by 4" wood posts with knee braces; building is in good condition; no additions.

Equipment Storage Building

View to NE

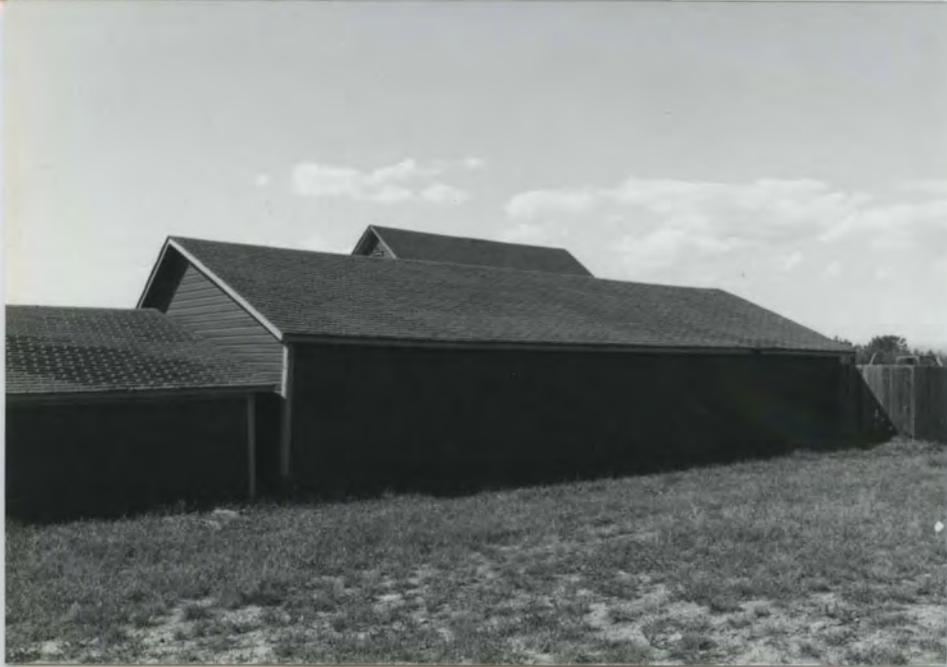
Roll CM-32 Frame 19

Equipment Storage Building
9 September 1996

View to SW

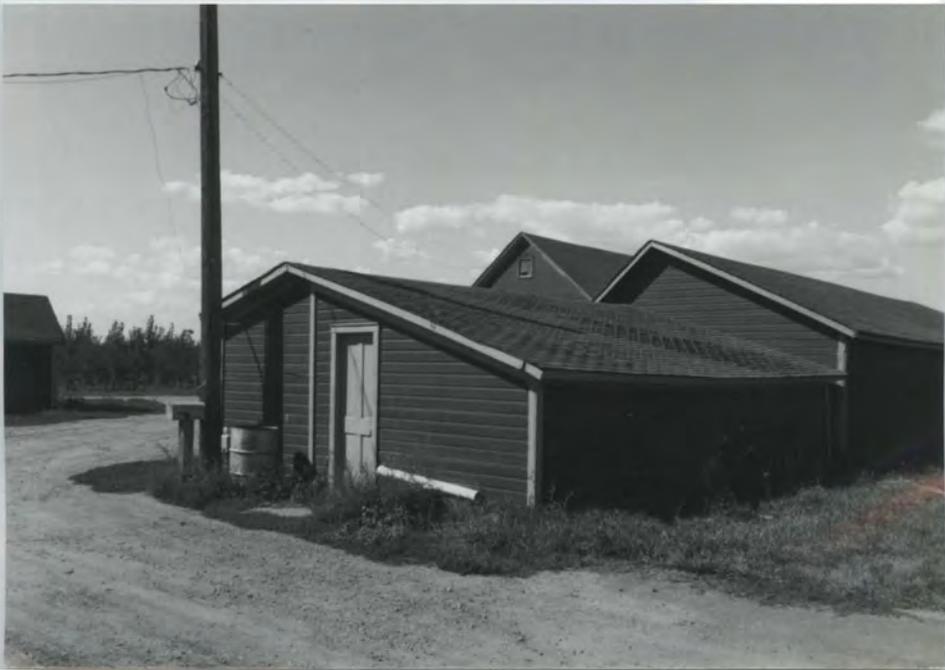
Roll CM-32 Frame 17

rectangular plan; 19' N-S by 24' E-W; one story; low poured concrete foundation; painted red horizontal weatherboard siding with painted blue 1" by 4" corner posts; low-pitched saltbox roof with brown wood shingles and boxed eaves (may originally have been two separate shed roof buildings that were joined together); no chimneys; band of four 6-light fixed-pane windows on the south elevation; single painted blue wood-paneled door on the east elevation; non-original unpainted plywood door, side-hinged with metal strap hinges, located at the west end of the south elevation; building is in good condition; no additions.

Chicken House
9 September 1996

View to SW
